Case 258 : Narrative

Case Vehicle (A): 2000 Dodge	Vehicle (B): 1999 Peterbilt
Type: Durango SLT, 4-door 4x4	Type: Tractor-trailer
Driver: 31-year-old female	Driver: 44-year-old male
CDC: 12-FDEW-3	CDC: 99-0000-0

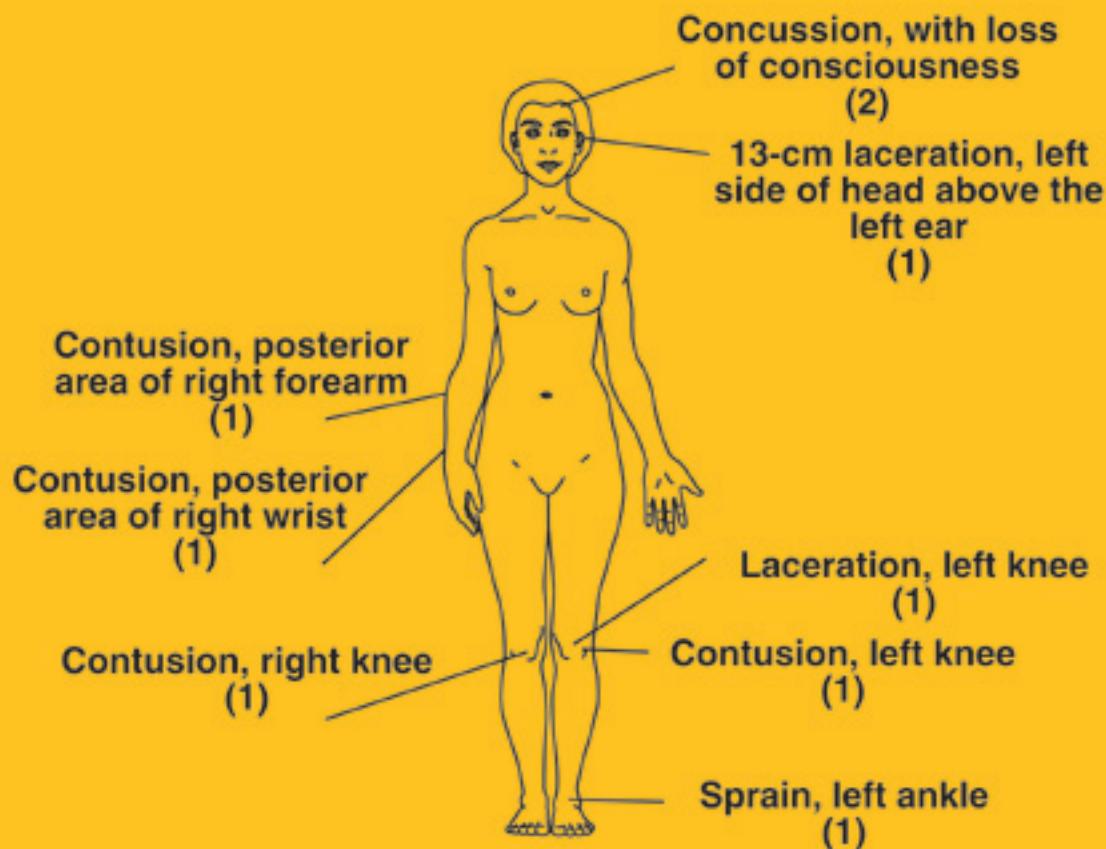
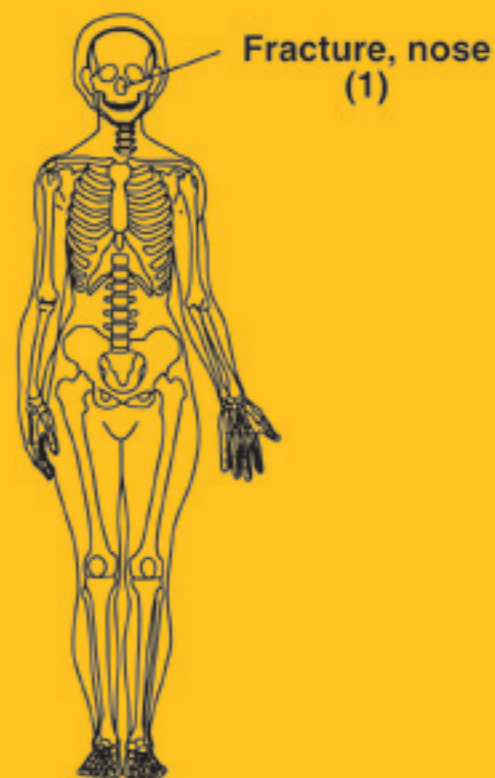
Occupant: Driver	Age: 31 years	Gender: Female		
Restraints: 3-point belt worn; airbag deployed	Stature: 165 cm (5 ft, 5 in)	Mass: 65 kg (144 lb)		
Injury Description	A.I.S.	Injury Source		
—	—	Definite	Probable	Possible
Concussion, with loss of consciousness	2	—	—	Airbag
13-cm laceration, left side of head above the left ear	1	Unknown interiorsurface	—	—
Fracture, nose	1	—	Airbag	—
Contusion, posterior area of right forearm	1	—	Fan knob on center portion of dash/center IP	—
Contusion, posterior area of right wrist	1	—	Fan knob on center portion of dash/center IP	—
Laceration and contusion, left knee	1	Knee bolster	—	—
Contusion, right knee	1	Knee bolster	—	—
Sprain, left ankle	1	—	Toe pan	—
Maximum A.I.S. Level	2	—	—	—
Injury Severity Score	6	—	—	—

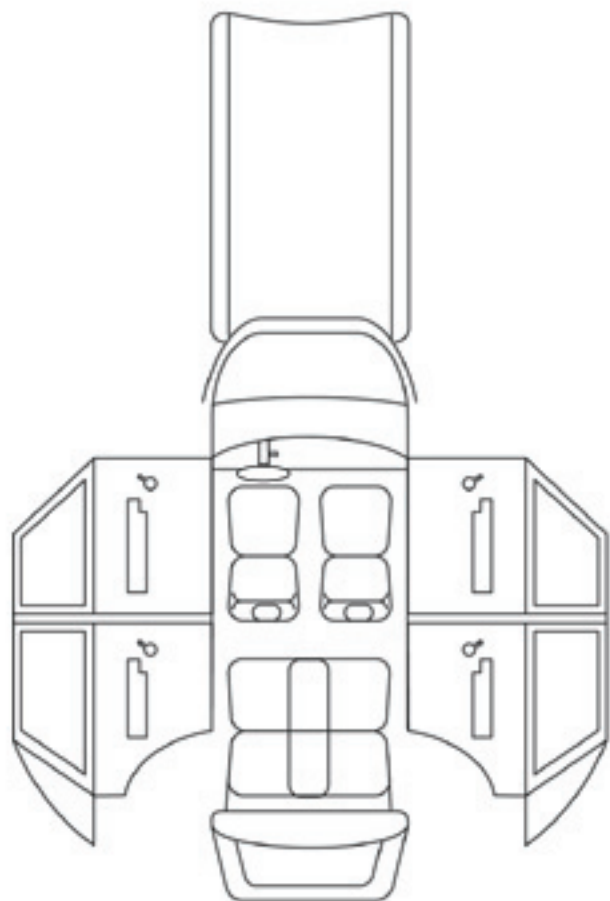
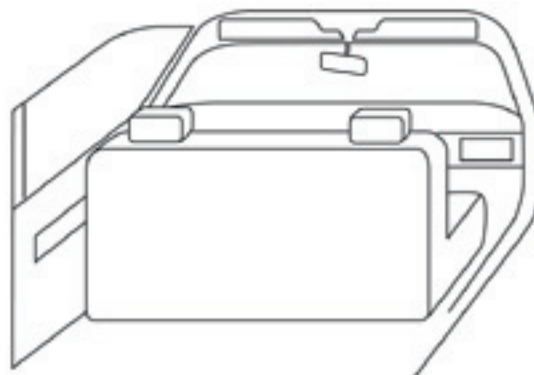
DR Belt: belt webbing cut
mid-position on B-pillar
